STATE LIBRARIES, ARCHIVES AND MUSEUMS **FINAL NEEDS ASSESSMENT**

SEPTEMBER 2009

State of Alaska, Department of Transportation and Public Facilities
for Alaska Department of Education and Early Development
Division of Libraries, Archives & Museums
P.O. Box 110571
Juneau, AK 99811

RISE Alaska, LLC
880 H Street, Suite 101
Anchorage, AK 99501
(907) 276-8095
www.risealaska.com

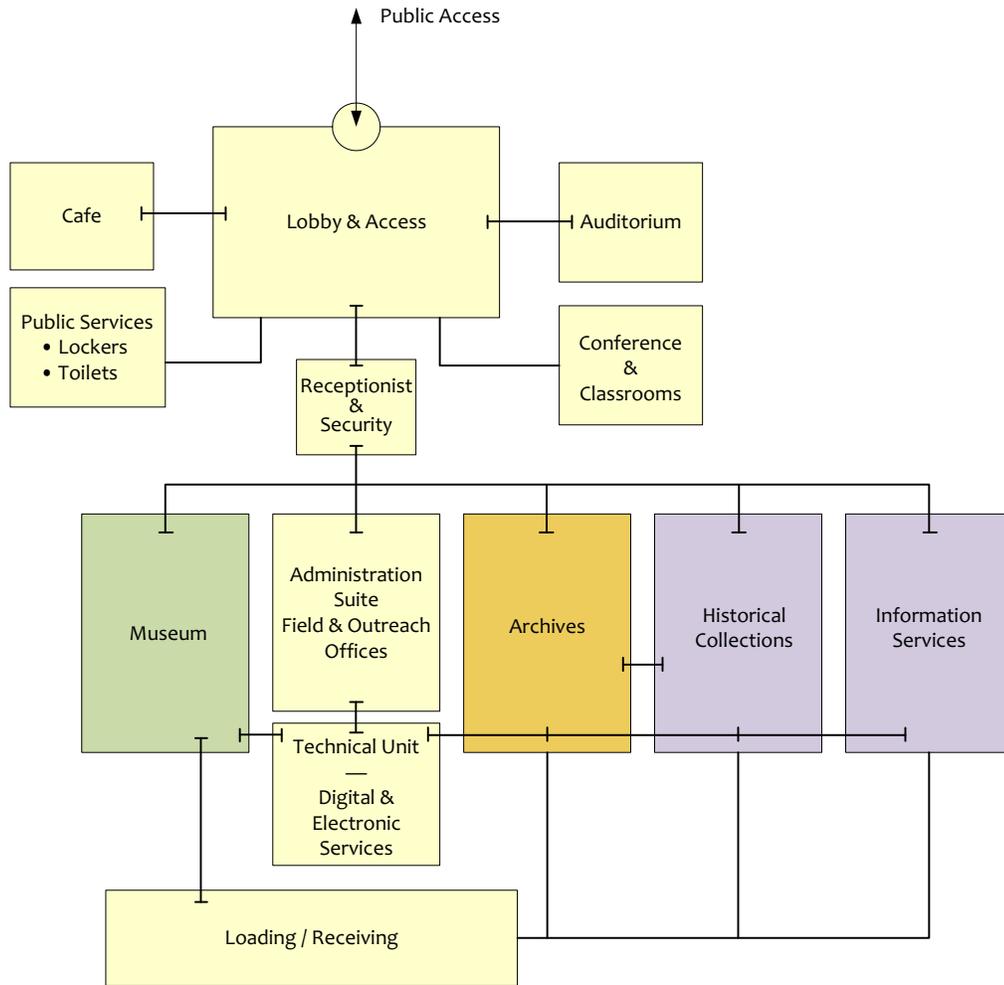
Facility Relationships

- KEY**
- ↔ FLOW DIRECTION
 - |— MANDATORY ADJACENCY
 - STRONG ADJACENCY
 - - - CLOSE ASSOCIATION

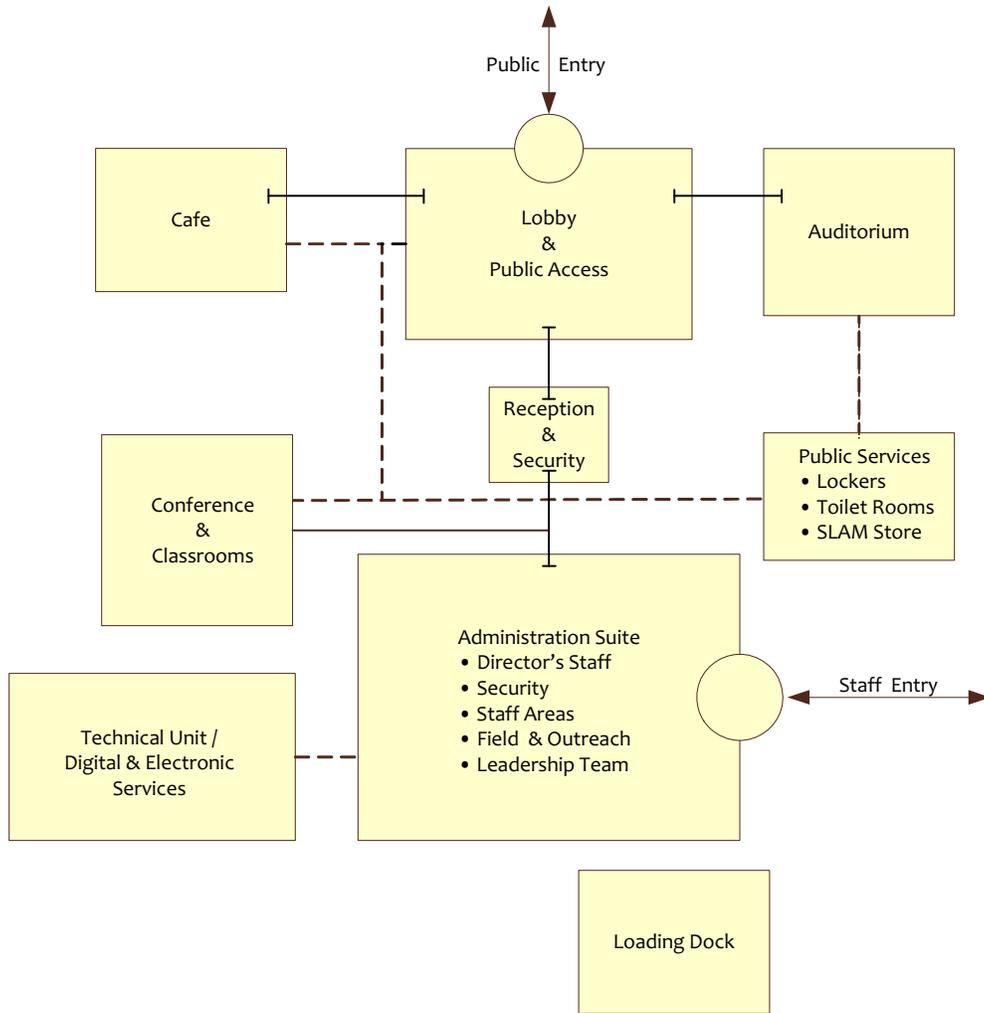
Administration, Public Area and Unassigned Space

- ↔ FLOW DIRECTION
- |— MANDATORY ADJACENCY
- STRONG ADJACENCY
- - - CLOSE ASSOCIATION

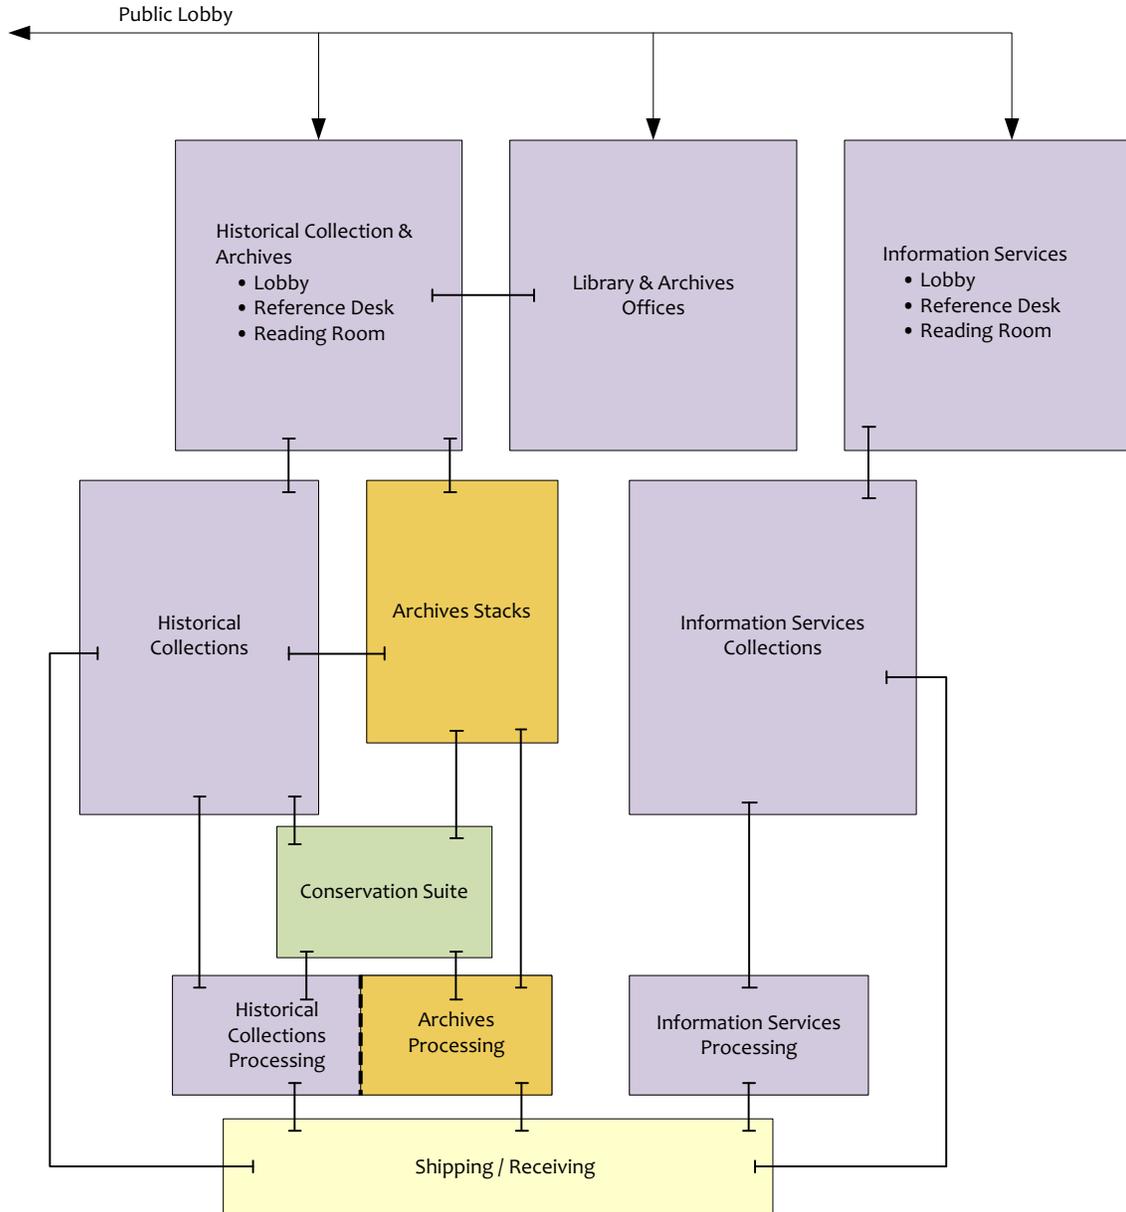
Libraries and Archives

- KEY**
- ←→ FLOW DIRECTION
 - |— MANDATORY ADJACENCY
 - STRONG ADJACENCY
 - - - CLOSE ASSOCIATION

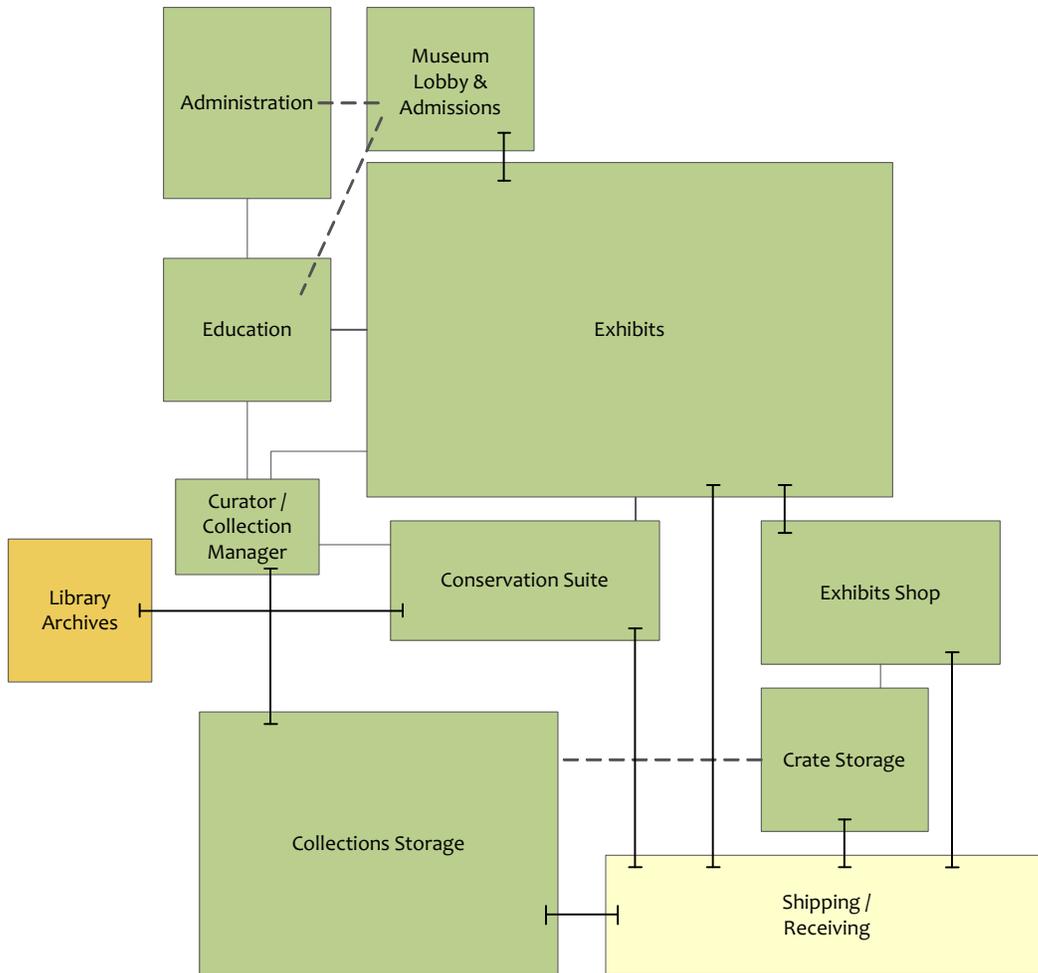
Museum

- ↔ FLOW DIRECTION
- |— MANDATORY ADJACENCY
- STRONG ADJACENCY
- - - CLOSE ASSOCIATION

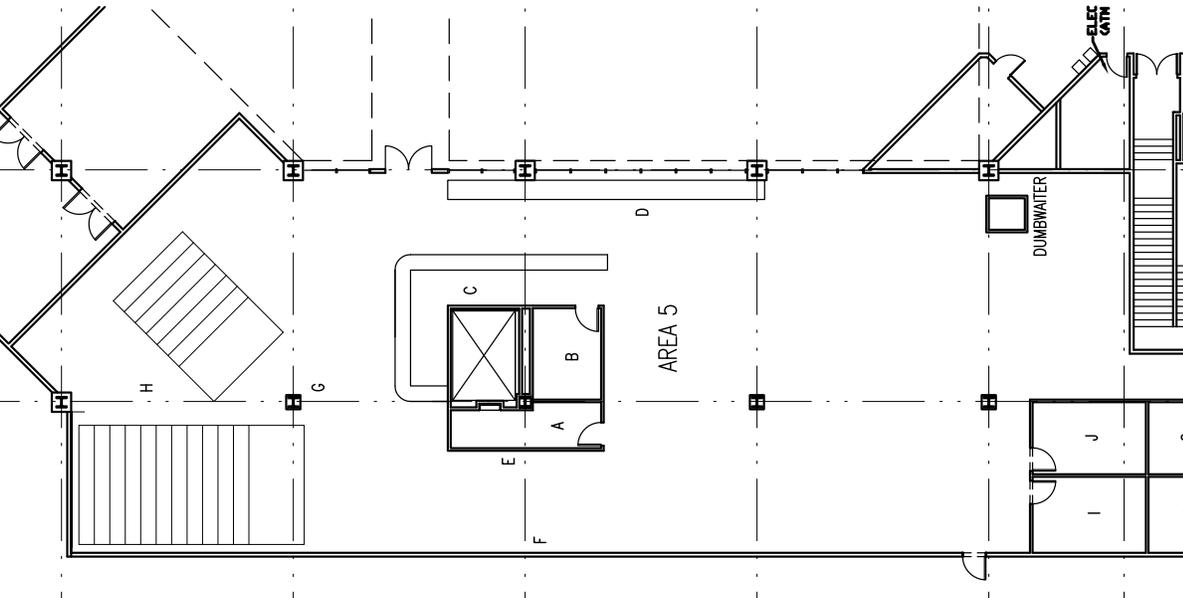
1 SOB Floor 8, AREA 5 ————— 4' 8' 16' 32'

- 6823 GSF
- State Library — Primary reading, stacks, support.
- A: Storage
- Audio tape duplication
- Separate station desirable
- Office Supplies Storage
- Quiet room for tutorials
- Add separate room in future plans
- Station for books to be reshelved
- C: Reception area
- 60'—10" in. ft. of service counter
- D: Computer area for public
- Six computers
- Two Microfilm readers
- Three printers
- E: Newspaper microfilm storage
- Three microfilm readers
- F: Four study areas
- G: Two microfilm readers
- Copier
- H: Two rolling racks
- I: Office
- J: Office

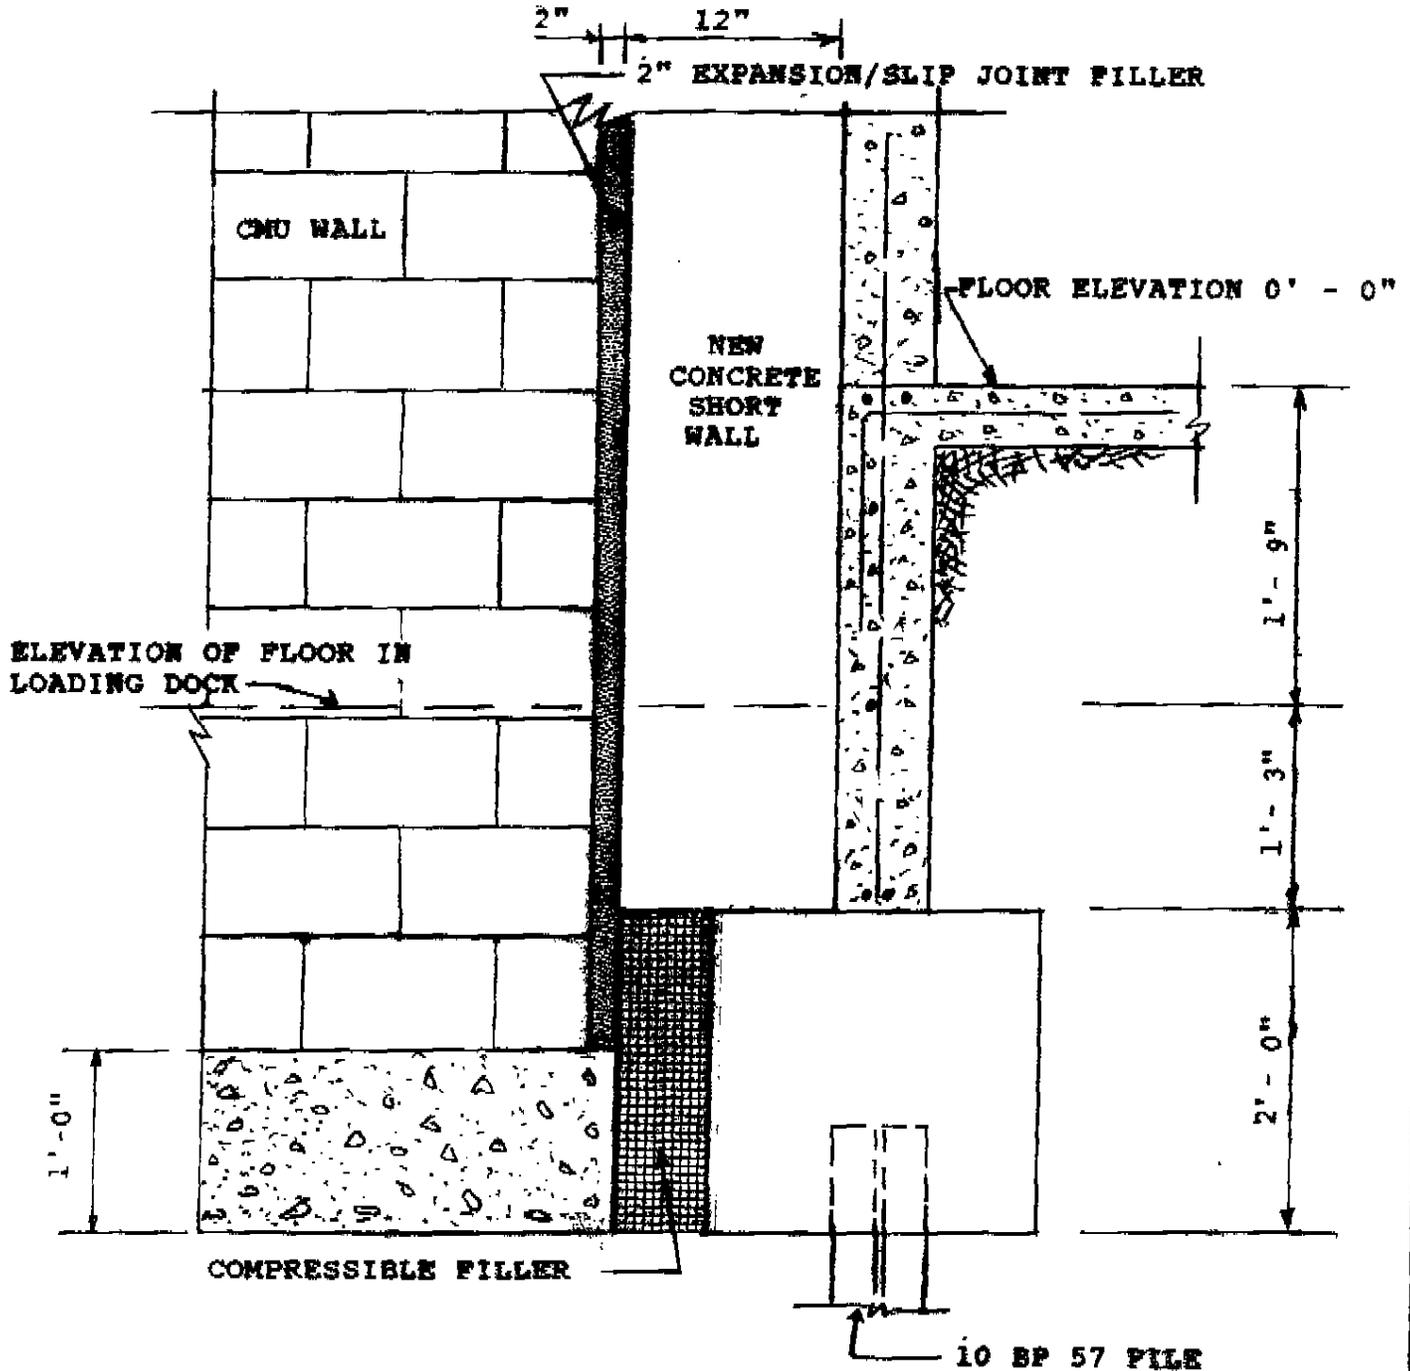
SECTION A LINE B

CONSTRUCTION OF NEW SLIP JOINT AT PILE CAP AND FOOTING

The existing 10,843 square foot Archives building was constructed in 1974. Unfortunately, structural problems were identified as early as 1980 when the State conducted a building condition survey which noted structural movement and cracking within the building. Discontinuous settlement seems to be the root of the structure problem with the northern portion of the building resting on natural occurring rock and the southern portion on fill.

The settlement and resulting cracking of masonry and concrete walls and floors has been the focus of two reports prepared by independent engineering firms, R & M Consultants and BBFM Engineers. Copies of these reports can be found in Appendix B of this document. Both reports noted the structural movement and the resulting damage caused to the building. The structural deficiencies are causing further failures throughout the building envelope. Water is entering the building from many openings including the roof, walls and windows. All allow significant amounts of moisture to enter the building. This condition is obviously of great concern as the threat to protection of priceless documents is great. At this time the Archives staff has managed to secure the collections stack area, but water migration through wall cracks and other structural related deficiencies will continue to be a threat throughout the building.

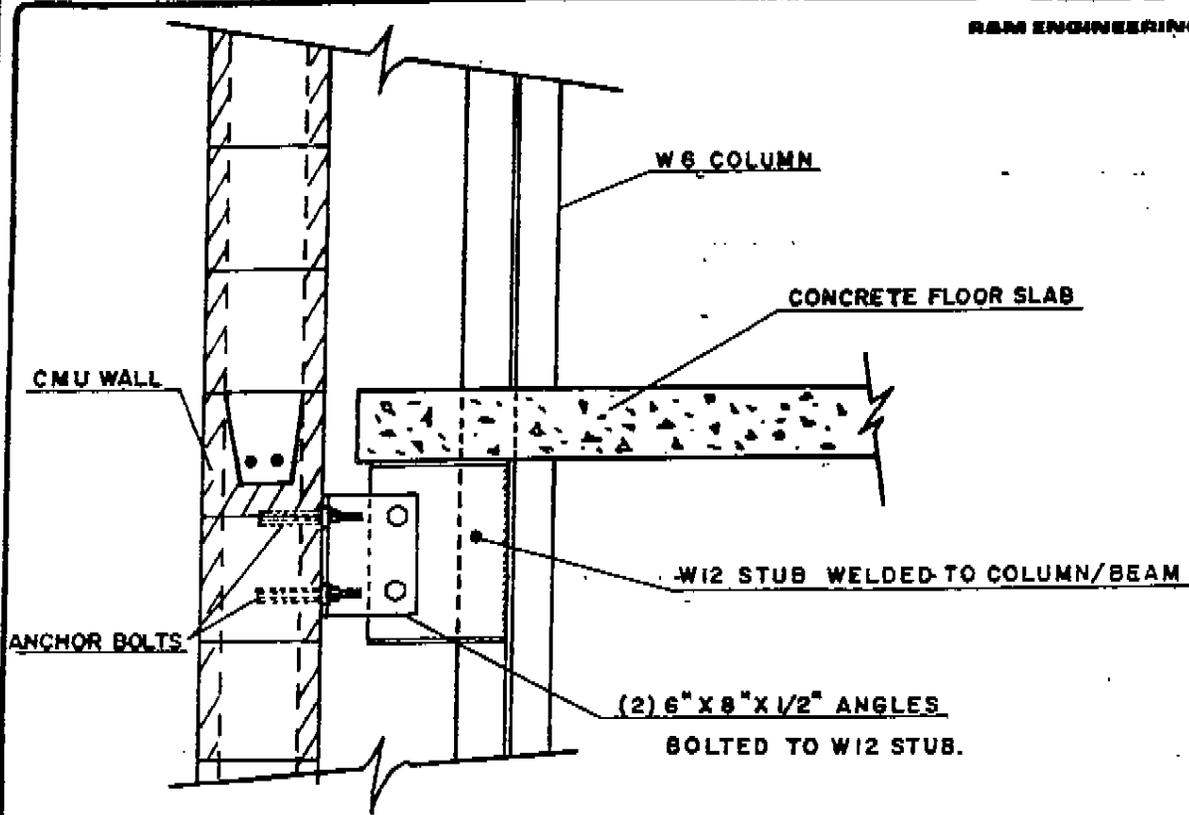
STORAGE AREA WALL - OFFICE FRAMING TYPICAL CONNECTION DETAIL

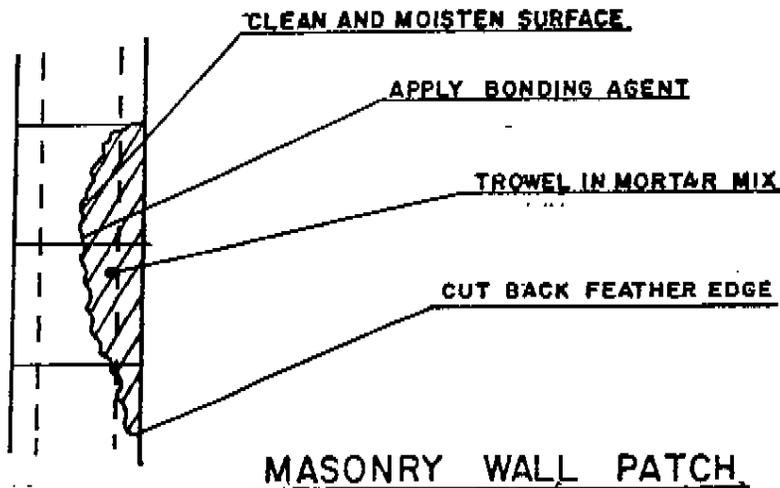
DATE 3/88	SCALE N.T.S.	DRAWN BY G.W.	CHECKED BY A.S.	PROJECT NO. 881301	DRAWING NO. 2
---------------------	------------------------	-------------------------	---------------------------	------------------------------	-------------------------

MASONRY WALL PATCH

- a) Drill a hole at the top of the masonry unit cavity. If the cavity is not grouted, pour in a non-shrink grout mix to fill the cavity.
 - b) Patch surface cracks with the mortar mix described in 2A or by rubbing a neat cement/water paste into the fine cracking with burlap sacking.

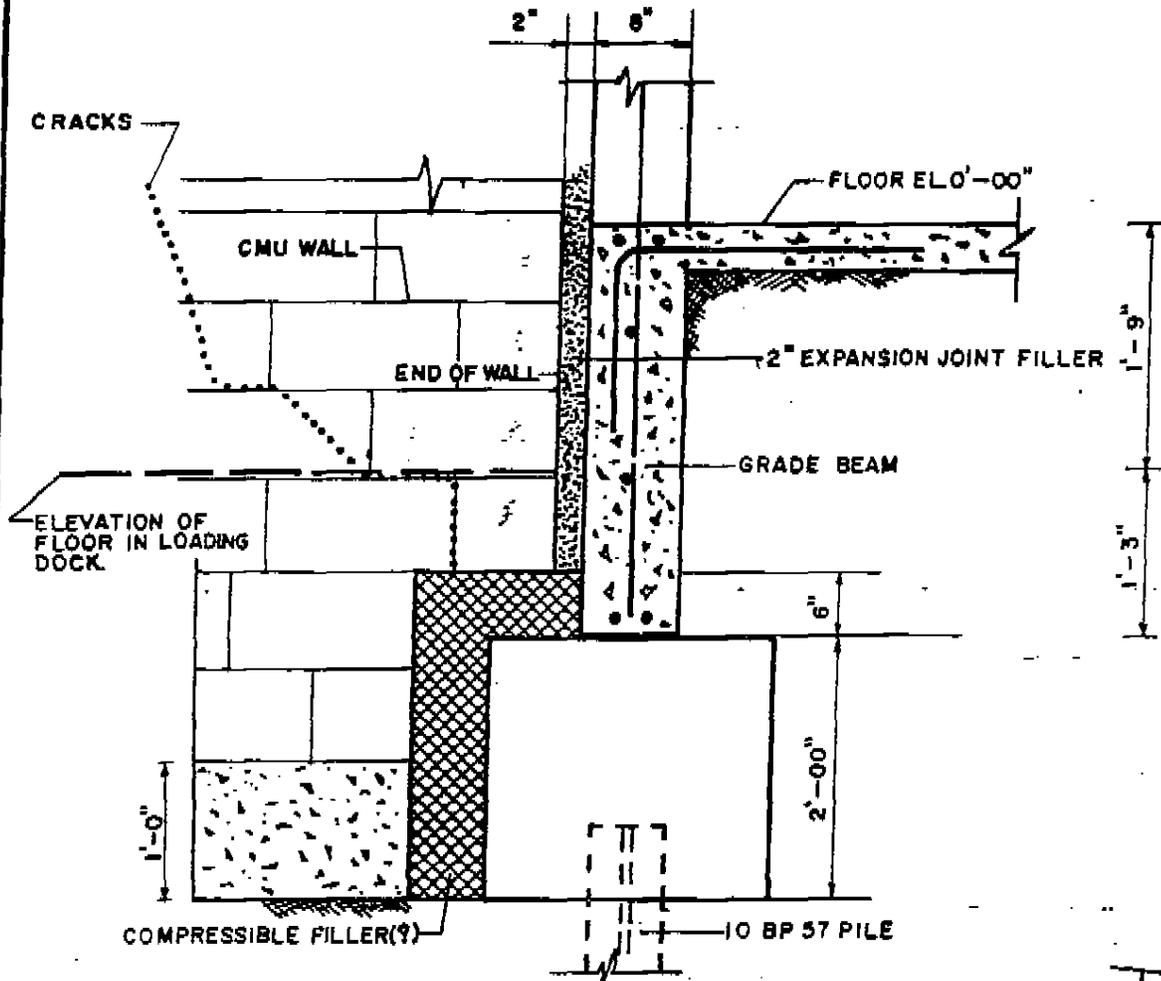
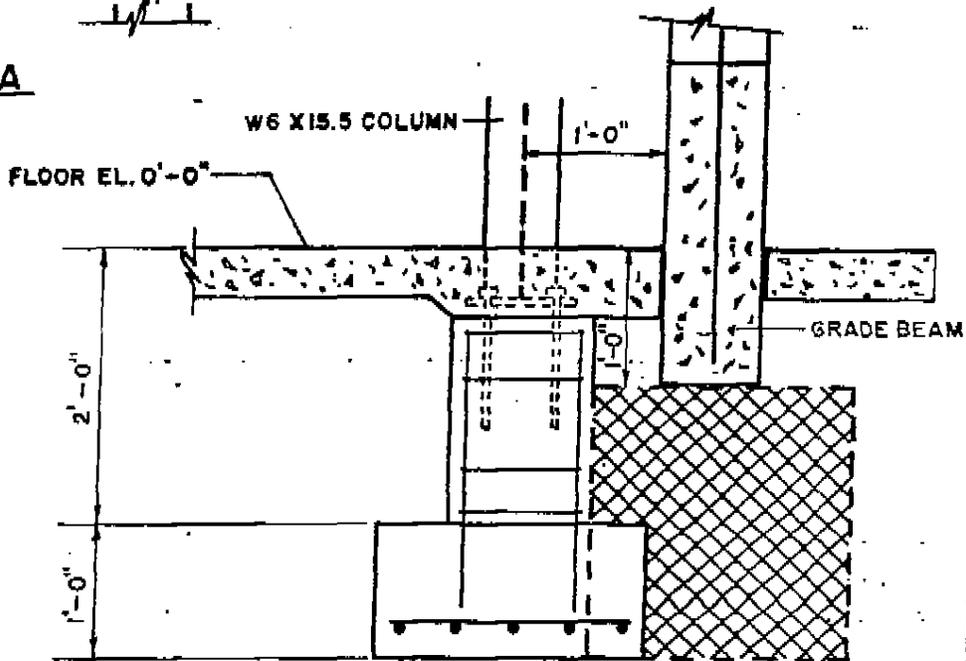
DATE 3/88	SCALE N.T.S.	DRAWN BY G.W.	CHECKED BY A.S.	PROJECT NO. 881301	DRAWING NO. 3
---------------------	------------------------	-------------------------	---------------------------	------------------------------	-------------------------

SECTION A
LINE B

SECTION B
LINE D

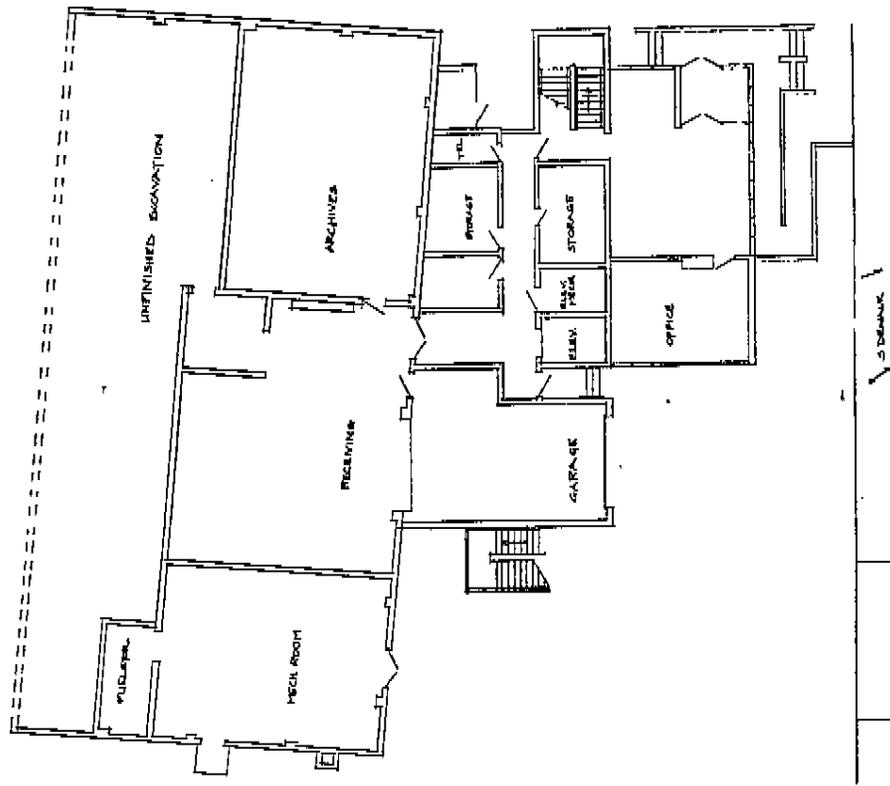
FIRST FLOOR PLAN

RECORDS CENTER

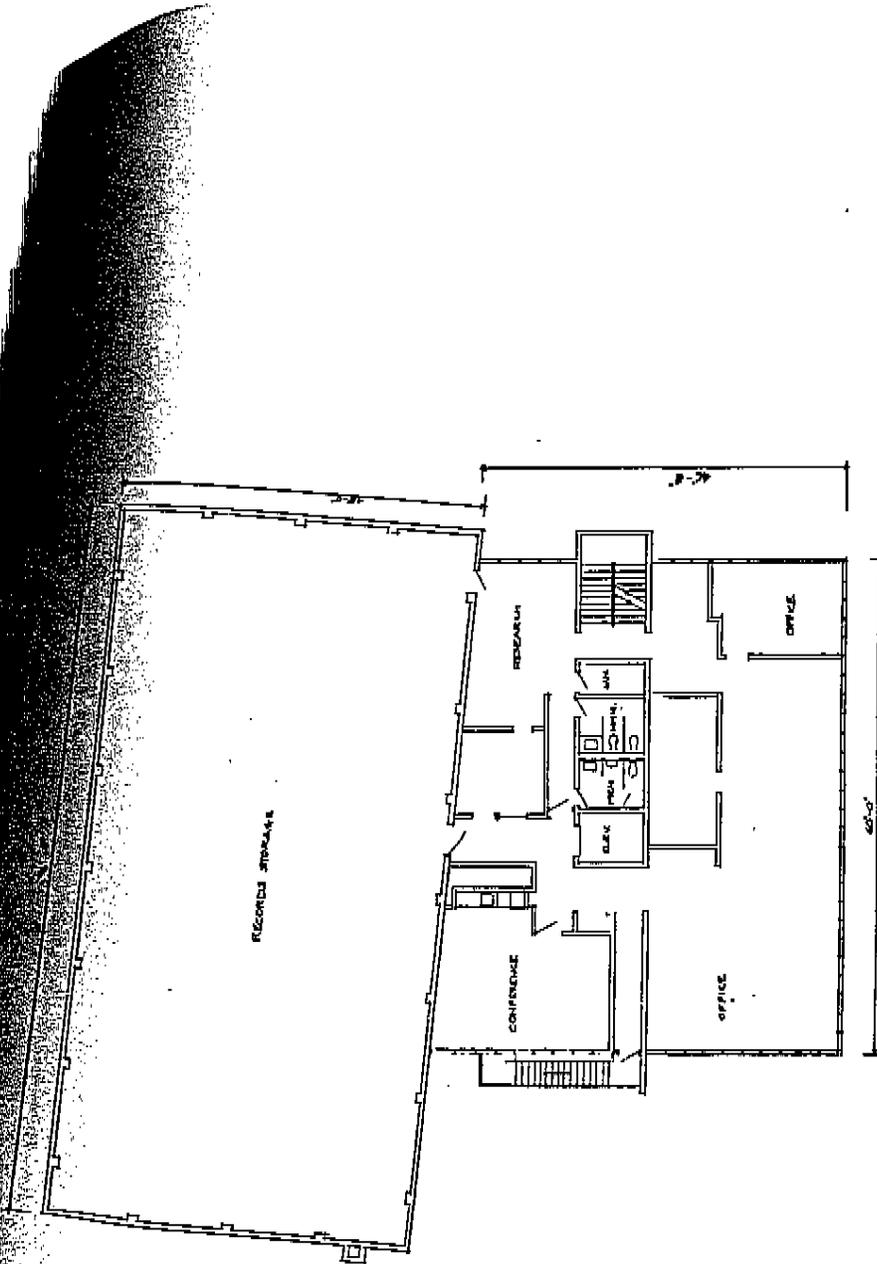
SECOND FLOOR PLAN

RECORDS CENTER

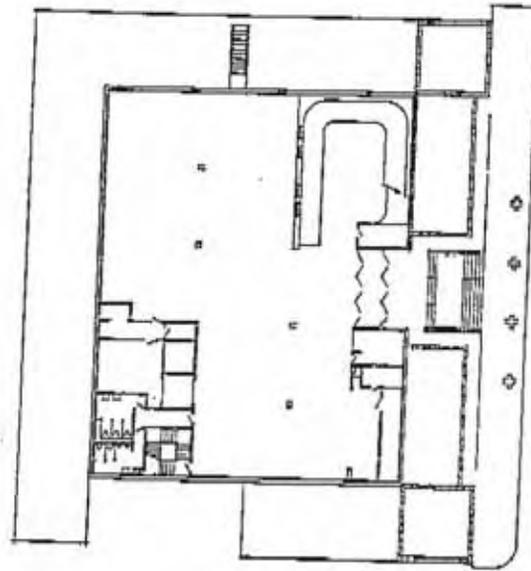
MAIN FLOOR PLAN

ALASKA STATE MUSEUM

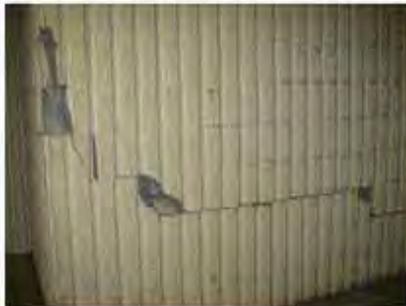
A wall displacement.JPG
