# 2010 Alaska Bridge Report

Kuskulana River Bridge, McCarthy Road

**Alaska Department of Transportation and Public Facilities**

**March 2011**

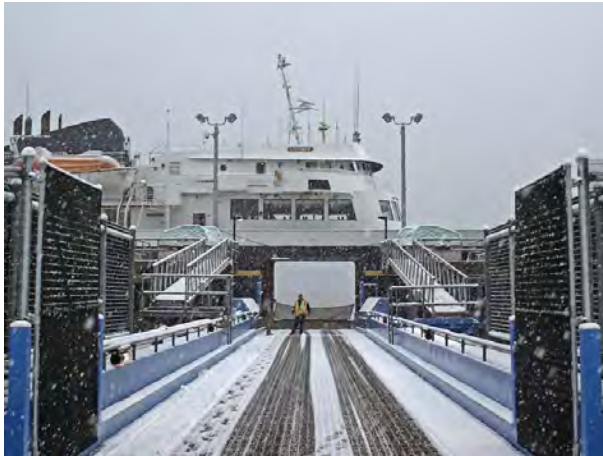
Figure 18. Ferry Terminal Ramp

**Specialized Structures.** Significant travel occurs in the state via the state ferry system and by seaplane. The state's ferry vessels link to the uplands at state ferry terminals with ramps that

the FHWA classifies as bridges in the National Bridge Inventory System (NBIS). The FHWA classifies these specialized structures as functionally obsolete because they handle only one-way traffic at low speeds; however, they are well suited to their intended purpose and are safe to use.

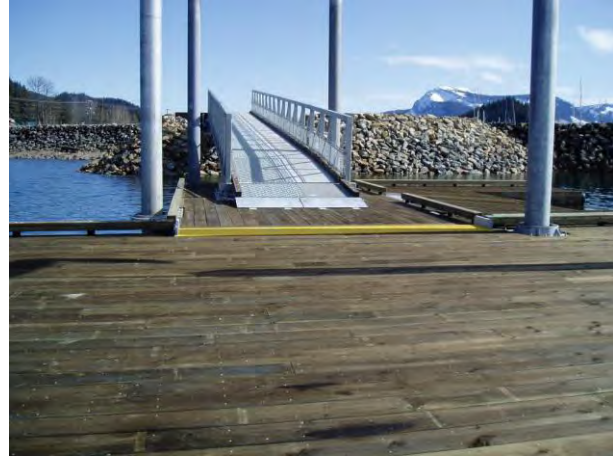
Figure 19. Hoonah Seaplane Float Ramp

Likewise, many seaplane floats in the state have drive-down ramps for delivering freight, passengers and luggage directly to the aircraft. These ramps, also in the NBIS, are not designed to FHWA bridge standards as they are usually one-lane wide, handle low volumes of traffic and only accommodate light-duty vehicles such as vans and pick-up trucks. Discussions with the FHWA may lead to de-listing seaplane float ramps from the NBIS. However de-listing would mean that another funding source is needed to keep up with inspections and rehabilitation or replacement needs.
